SUBSIDENCE

At San Manuel

The following sequence of Images illustrates the development of surface subsidence at the San Manuel Mine in the period between 1956 and 1996.

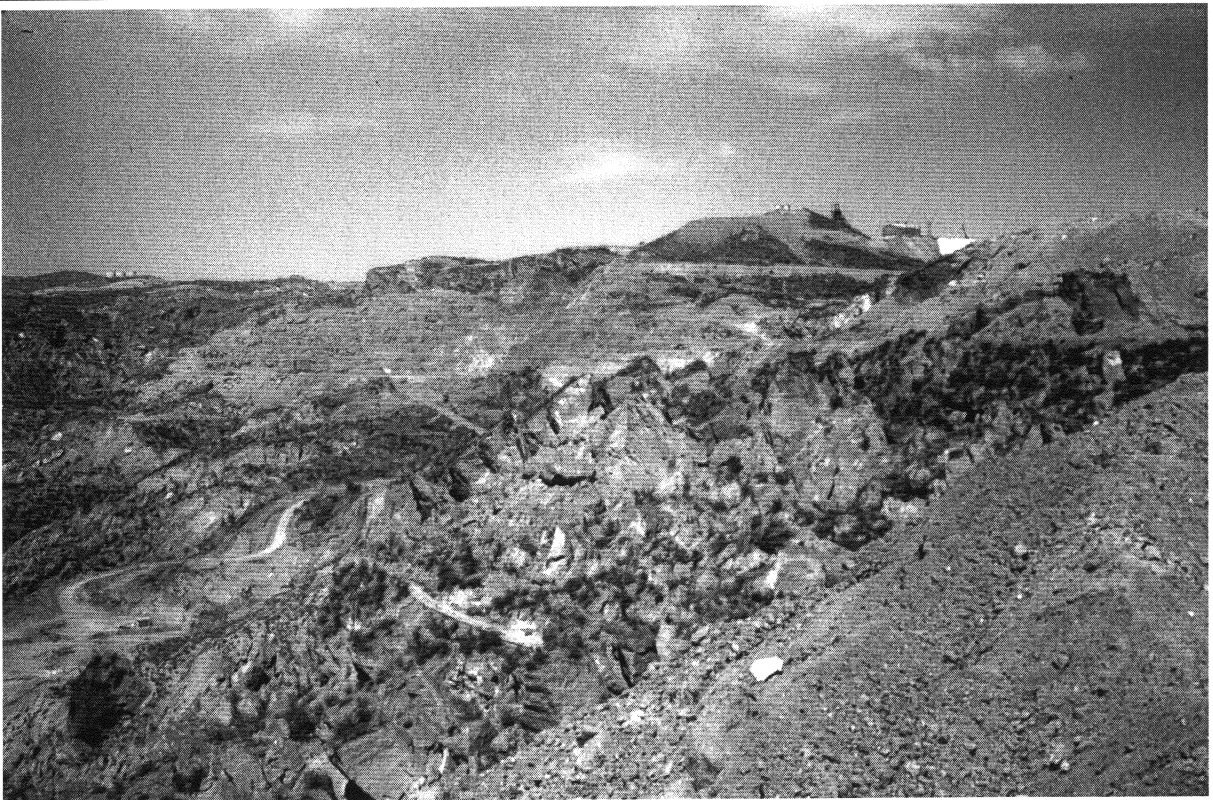
First Subsidence - 1956

The initial breakthrough to the surface caused by draw from the 1415 level of the San Manuel Mine occurs on June 16, 1956 when an area about 100 feet in diameter holed through, with the “plug” dropping approximately 30 feet. The hole was located over the west side of Block 9-1, which had been in production for 135 days at the time of collapse.

Concentric tension cracks (visible in the photo) immediately formed around the hole. Vertical distance from the 1415 level to surface was 1120 feet.

View is looking northerly across one of the Red Hill housing areas, which was still occupied at the time. Tiger town site lies behind the ridge with the houses and the top of the Collins Glory Hole is visible as the twin peaked hills on the left-central skyline.

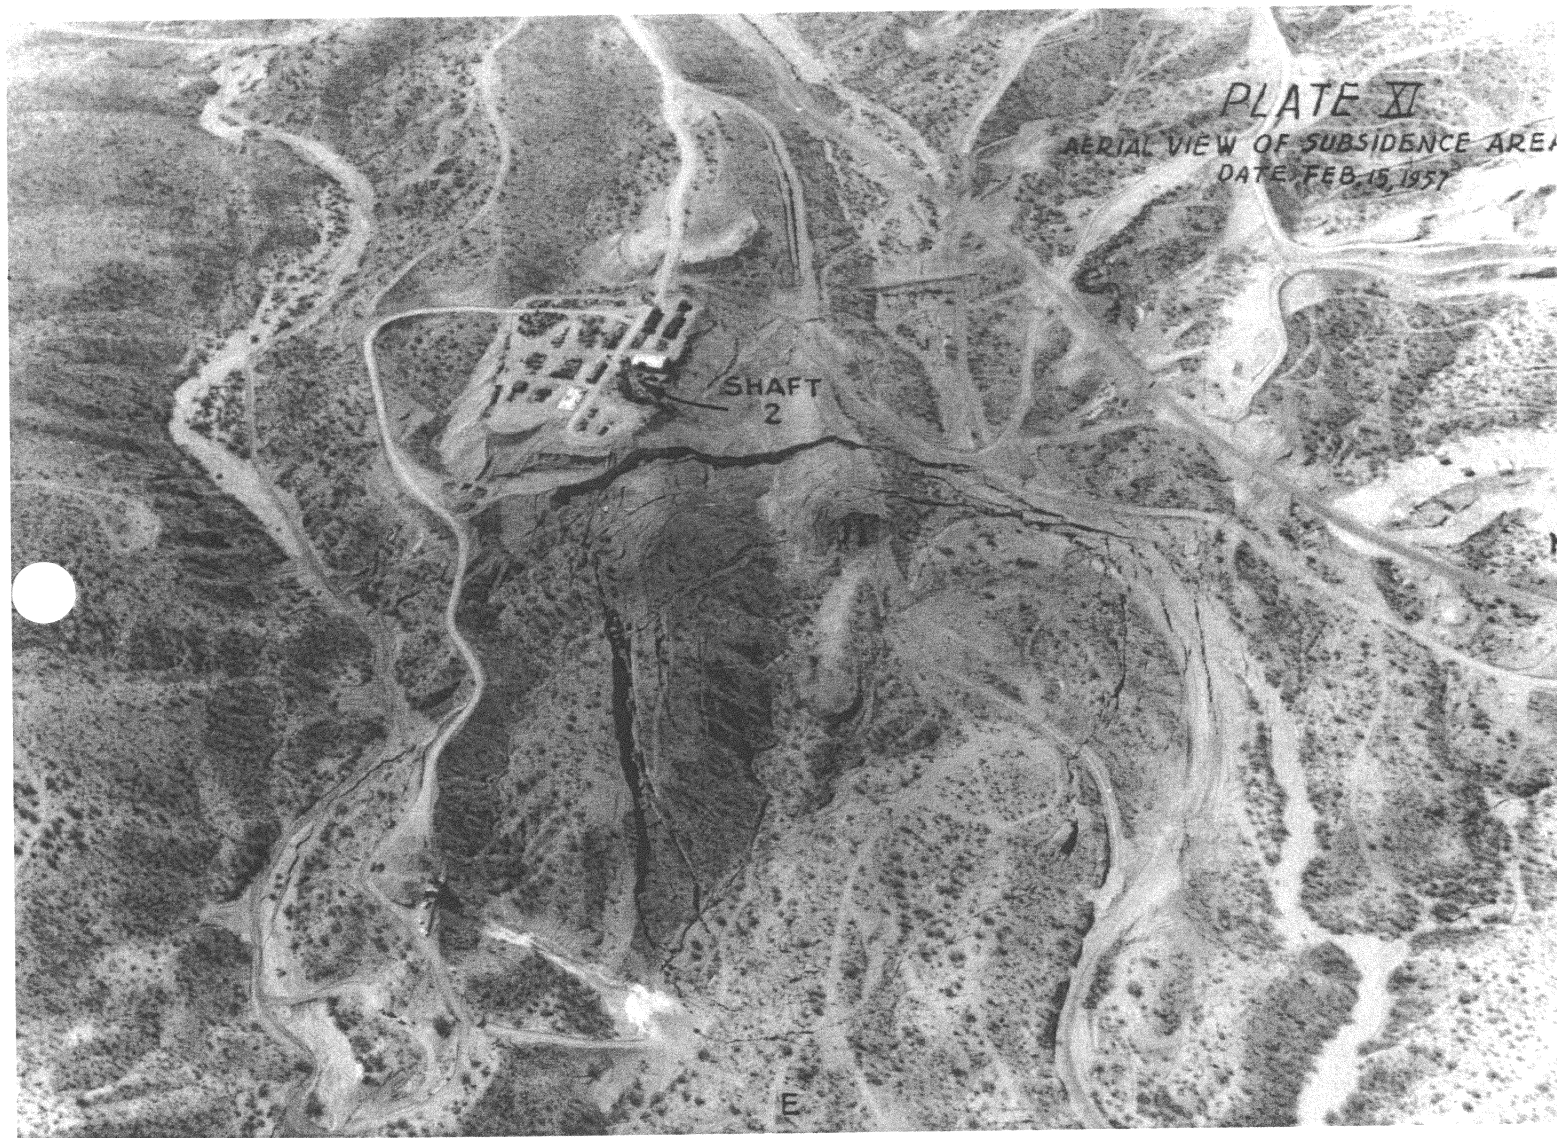
PLATE VI

AERIAL VIEW OF SUBSIDENCE AREA

DATE FEB. 15, 1957
